# **Accident Hazards on National Highways in Bangladesh**

The main purpose of this paper is to describe the prevalence of road environment hazards and deficiencies contributing to accidents on national highways in Bangladesh by citing examples of on-scene studies of selected high accident locations. The paper also highlights various corrective engineering measures relating to roadway geometric design and environmental improvements. It further comments on the urgency of introducing new approaches of road safety audit, inspection and risk assessment programs for rapid and sustained improvements of road safety at marginal cost.

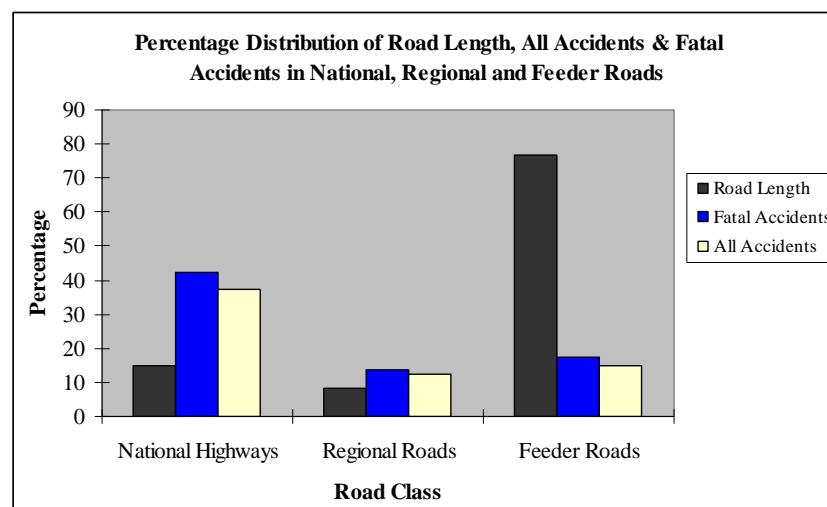
Detailed analysis and findings of accident investigation on national highways have been reported by Hoque (2006), and Hoque et.al. (2006). The distribution of total accidents according to road types is national highways 38 percent, 12 percent regional roads, 15 percent feeder roads, and others (including city streets) 35 percent. Figure 2 presents the comparative distribution of accidents, fatalities and road lengths by road types. Of the accidents and fatalities of known locations, the share of national highways is much higher, 56 percent and 61 percent respectively. It is clear that accidents on the national highways are of primary concern to improve the road safety situation in Bangladesh. More detailed analysis of accident distribution revealed that accidents are highly clustered on few sections of the national highways demonstrating that accidents are amenable to site specific treatments. This aspect has been examined in some greater detail to identify locations with high concentration of accidents and fatalities. The intensity of accidents (accidents per km) on national highway network was examined to identify the links of high concentration of accidents. This is shown in Figure 2. It can be seen that the national highway links in the central part connecting northern

Figure 2: Percentage Distribution of Road length, Total accidents and Fatal Accidents in National, Regional and Feeder Roads

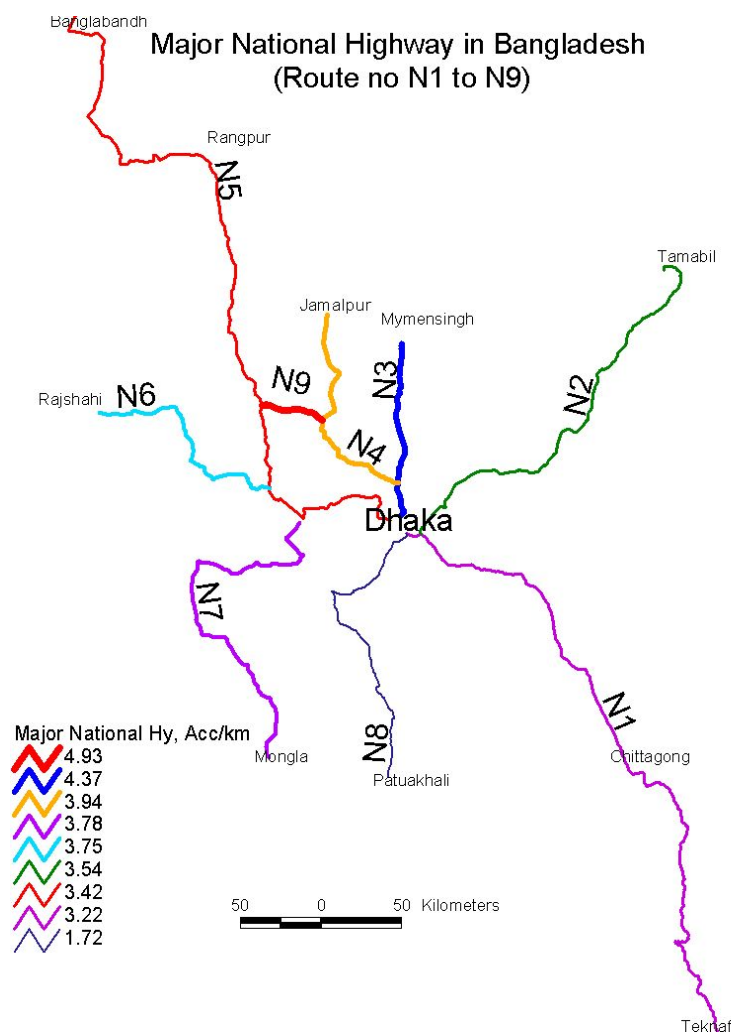
regions are having high incidence of accidents. Of particular concern is the link N9 which represent the link with Jamuna Bridge and its approaches. On average nearly 100 accidents occurred on this link of nearly 38 km. Detailed studies of the accidents on this link are reported in Hoque et. al. (2008).

Figure 3: Major National Highways in Bangladesh Showing the Intensity of Accident Distribution (Accidents per Km.)

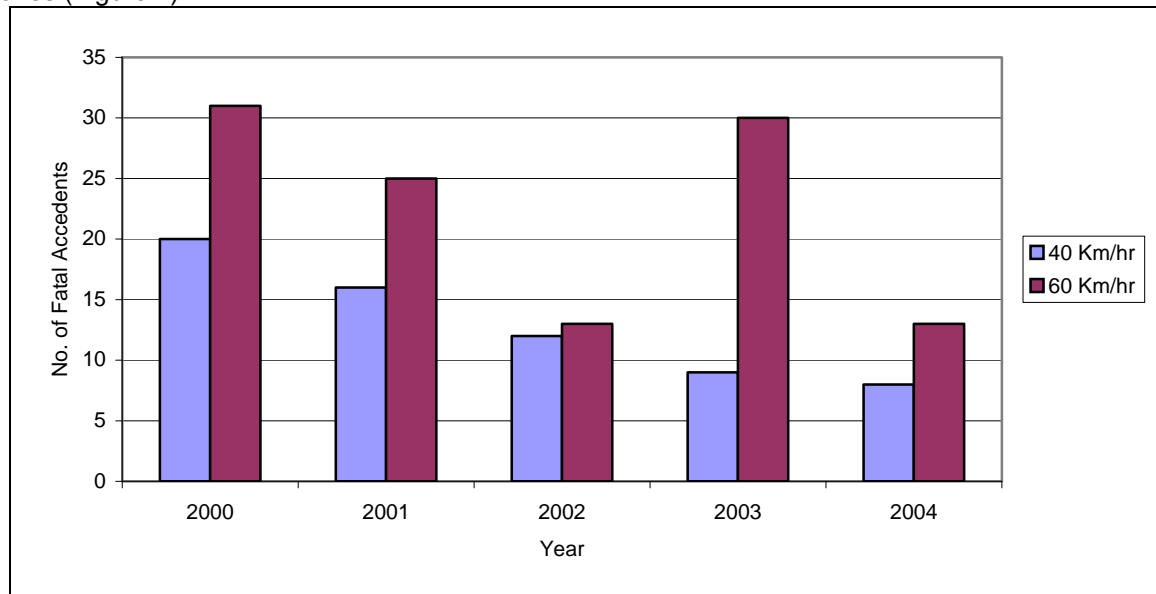
More frequent accident types on the national highways were also identified (see Hoque et. al. 2006c). Of the total reported accidents, hit pedestrian emerges as the most common type of accidents amounting to 40 percent of total accidents and 47 percent of all fatal accidents. This is followed by head on (18%), rear end (13%) and overturning (11%) types of accidents. These four accident type groups accounted for 82 percent of all accidents and 86 percent of all fatal accidents. The greater incidence of head-on types collision on national highways as compared with its share in total accidents, highly justifies the necessity of separating opposing traffic stream. The incidence of aggressive speeding was also evident on national highways. An examination of the distribution of accidents on a national highway corridor was made according to specified speed zones. It showed that higher incidence of accidents occurred on the designated highway segments of high-speed limit zones (Figure 4).

Figure 4. Distribution of Fatal Accidents on National Highway Corridor (Dhaka-Aricha Highway Section) with Varying Speed Limits (Newaz et al., 2006)

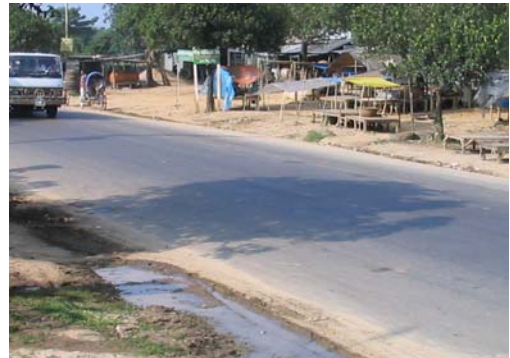
- There is no dedicated side walk or cross walk facilities for pedestrians and absence of regulatory/warning signs or signals.
- Most of the temporary shops and stalls are built just besides the road which obstructs the visibility when traffic from access roads merges into the main traffic stream.

- Very complex and high roadside frictions with varied local activates and functions due to high concentration of retail/trading centers.
- Overall situation is worsen by illegally use of the roadsides for piling of wooden logs and other goods, parking and loading /unloading activities which force the pedestrians use the high-speed road carriage way.

Roadside temporary shops and damage roadsides

- The conflicting requirements of pedestrians, traders, worker and deliveries have to be separated by physical separation of the roadside stalls and retail activities off the road.

- Treatment and re-location of physical obstructions e.g. poles, trees, shops and other objects.
- Adequate access control through proper geometric design modifications of access roads and placement of give way and stop signs and markings.

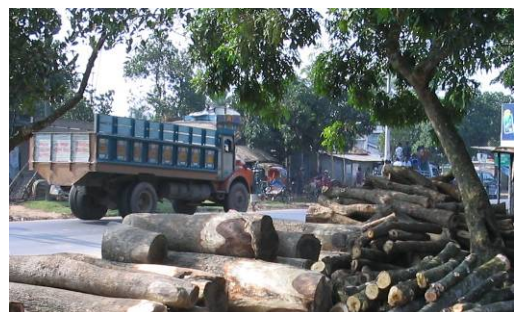
Stack of materials close proximity of roadsides

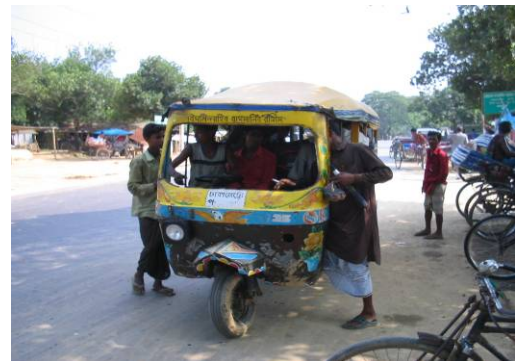
Tempos picking up passengers on roads are real danger for through traffic

- Designated pedestrian crossing facilities and refuges.
- Provision of rural bus bays to provide of road operation for bus to pickup/drop passengers
- Proper placement and maintenance of the regulatory and warning signs.

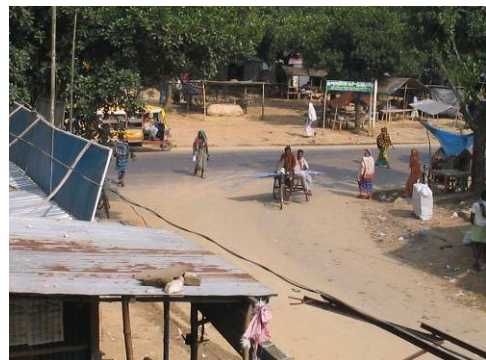
- High speed, high occupancy through traffic mostly commercial vehicles very often have conflicts with local low speed operated minibuses, tempos and other non-standard vehicles, particularly NMVs from access roads. Traffic from unmarked access roads also creates hazards.
- The volume of motorcycle traffic is also high and most of the riders don't use safety helmet which makes them one of the prime vulnerable road user groups.
- Non-motorized vehicles like rickshaws, handcarts, and bicycles are also frequent on the highway and share the same carriageways in the absence of treated shoulders.

Uncontrolled poorly designed access road

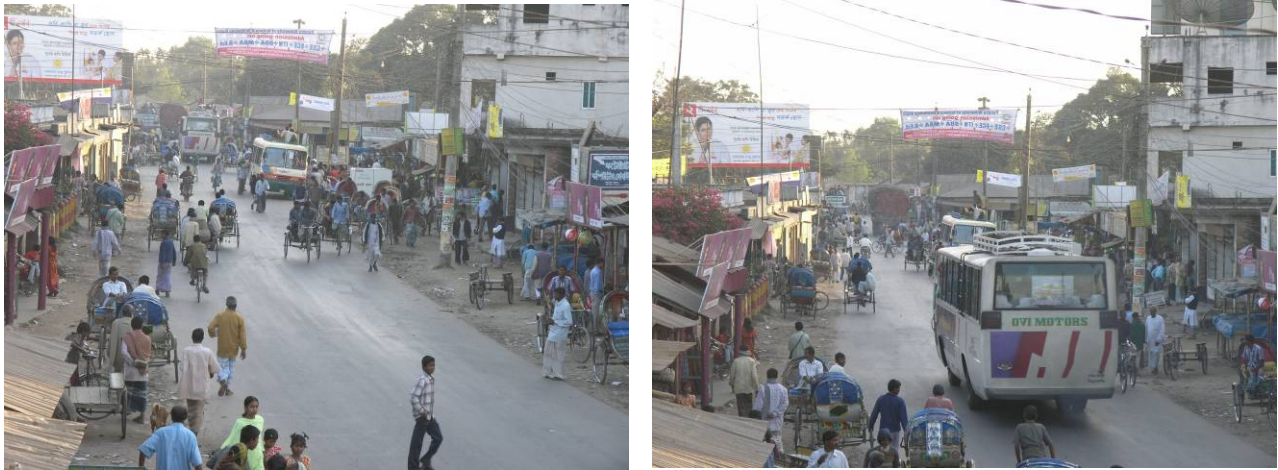
Figure 5: Free, unregulated and undisciplined on the highway.

Its an important growth centre. Many shops have been developed along both sides of the highway. Theses shops and several shop-related activities restricts pedestrians from using the shoulders along highway (see Figures 5). Furthermore, they create significant visibility problems when traffic from access roads merges into the main traffic stream. In addition to markets and shops, a cinema hall, a spinning mill and a fueling station are just beside this highway which are attracting significant number of traffic.

The problem characteristics of this site dictated similar physical and behavioural road safety countermeasures outlined for the previous site could be applied. An important safety measure demands priority at this site is the separation of shopping areas and road side stalls from the main road by service/frontage roads along roadsides to provide safe operation of the local settlement.

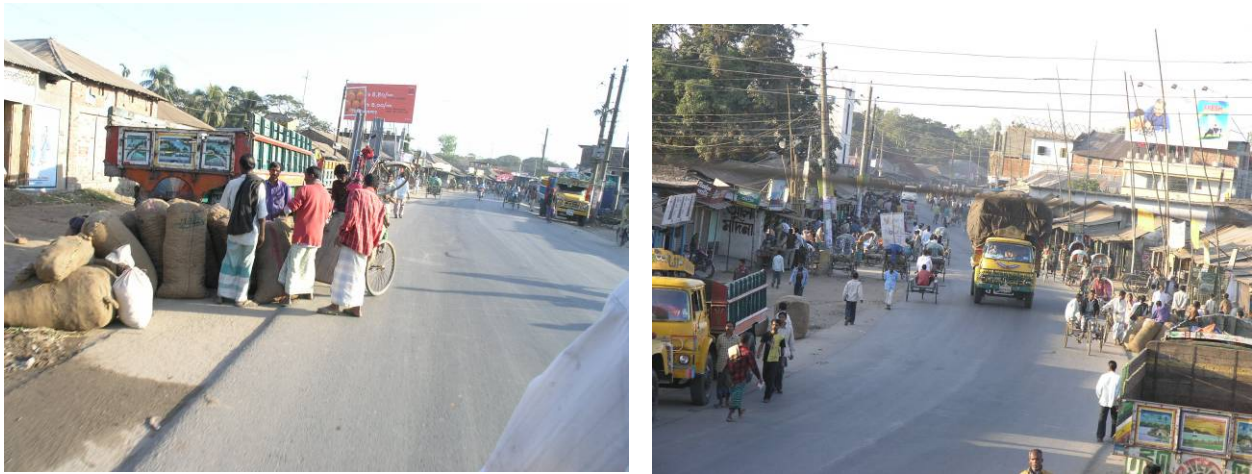
Figure 6: Hazards of truck loading and standing, roadside objects

Significant road environmental and traffic operation hazards were observed almost similar to that outlined in case study one. These include: uncontrolled road side land use development; road space occupation by road traders and commercial activities; high intensity NMV traffic in the absence of NMV facilities; vehicle loading/unloading, parking and damaged/broken vehicles on roadways;

absence of designated off carriageway bus stops, pedestrian facilities; road shoulder defects; road side objects; obstruction and vegetations, absence of road markings and other delineation devices and frequent uncontrolled abutting access and local side road accesses. The glimpses of such hazards are shown in Figures 6.

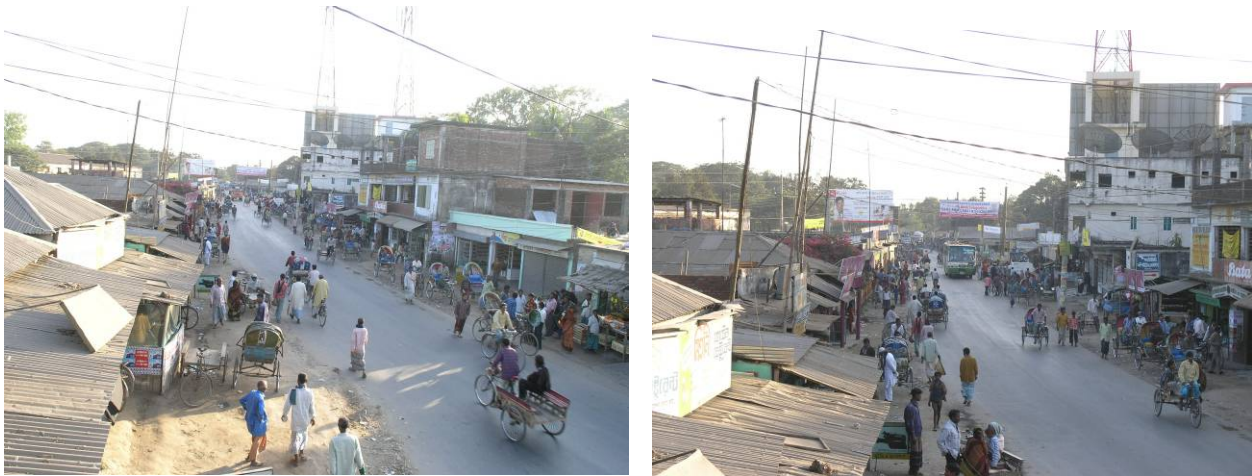
Figure 7: Roadside encroachment and high pedestrian movement reduce the effective carriageway width creating enormous safety hazards

- Since this location is the central place all economic, social and cultural activities of about seven adjoining villages, massive pedestrian activities are observed and the volume of pedestrians becomes highest during the *Hat* days. The pedestrian movement is dispersed, numerous and unregulated. There are no dedicated pedestrian sidewalk or crosswalk facilities and due to encroachment of shoulders, pedestrians are forced to use the carriageway.
